RENEWWRAP[®]

STRUCTURAL STRENGTHENING

CASE STUDY:

Central, CA Grain Silo

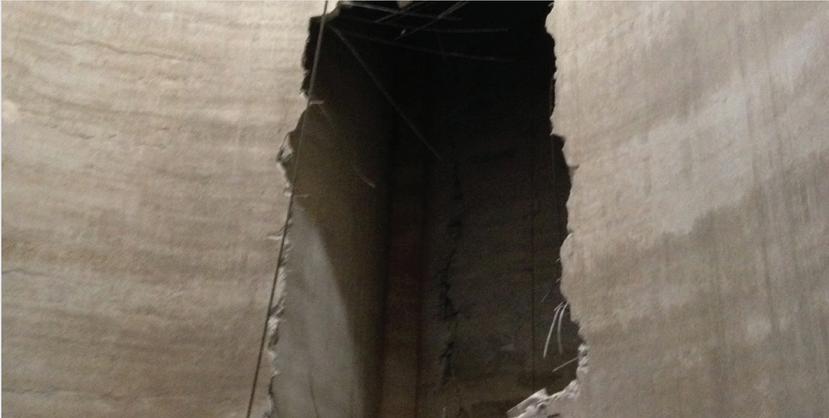
Standing at approximately 150 feet tall and 44 feet in diameter, silo had 10-inch thick reinforced concrete walls. In 2014 a small section of one of the walls failed and collapsed into the interstice. The detailed inspection that followed found vertical cracking at various locations around the perimeter of the three silos and an as-built bar spacing that generally exceeded the original design spacing

Failed wall section

Once the owner approved the proposal, scaffolding was quickly erected inside the silo to facilitate access to the entire wall surface area. The failed wall section was reconstructed using traditional cast-in-place techniques. The walls were then pressure washed to prepare the surface of the concrete to receive the RenewWrap™ FRP system. The cured FRP system was coated with an abrasion resistant coating to protect the FRP during normal filling/unfilling operations of the silo.

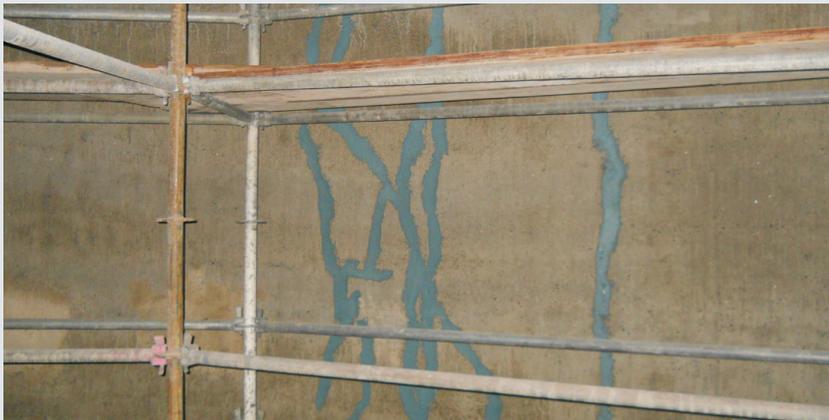
Typical crack pattern in silo walls

The owner was about to move forward with the same shotcrete solution used to repair on silo in 2005, when Ace Restoration & Waterproofing approached them with an alternate solution that involved using the RenewWrap™ fiber reinforced polymer (FRP) system. Ace assembled a design-build team to analyze and price various FRP strengthening scenarios and their disruption to the facility's operation. Finite element models were used to analyze multiple load cases including the impact of partially filling the interstices for stability in an attempt to optimize and reduce the cost of the repairs. After analyzing a number of approaches the designbuild team proposed installing the RenewWrap™ ESR CF600 carbon fiber strengthening system to the interior face of the silo wall.

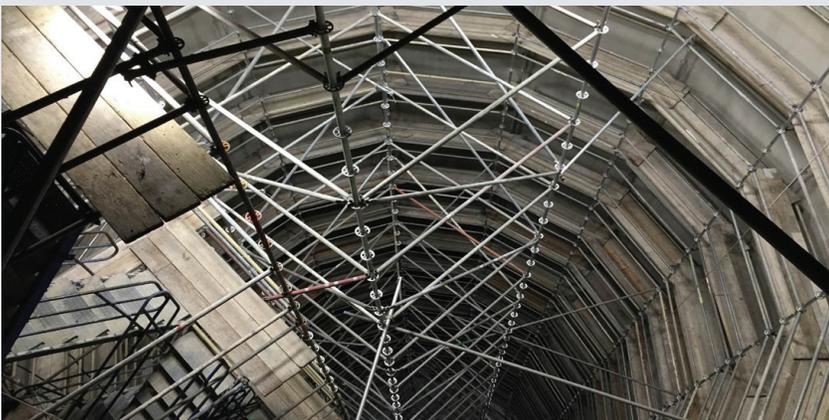
Scaffolding erected inside silo

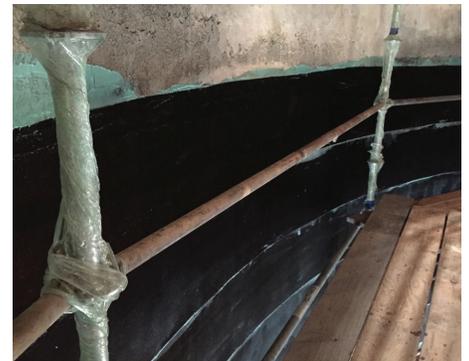
Hoop plies of RenewWrap ESR CF600

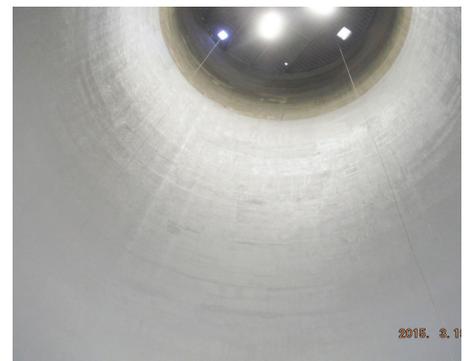
The silo was restored to its original design strength with practically no loss of storage capacity. The project was completed on time and on budget. The owner is now familiar with FRPs and is considering them for future projects.

Completed silo
